CV Axle Issues on Vehicles with Altered/Lifted Suspensions

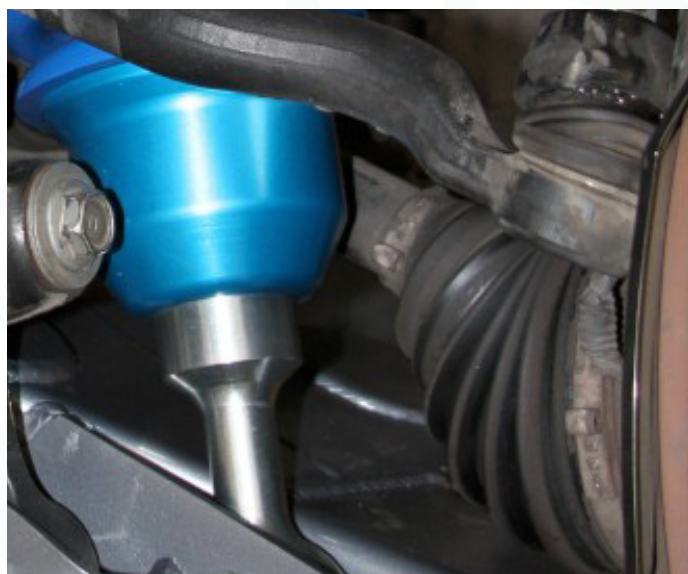
Vehicles with altered (lifted) suspensions create higher operating angles, causing the CV boots to experience higher operating temperatures because the boot bellows are in contact over prolonged driving conditions. This creates extreme heat due to friction from the boot bellows constantly rubbing together.

Close-Up Example: High operating angle causes the CV boot bellows to be in contact, creating extreme heat due to friction from the boot bellows constantly rubbing together.

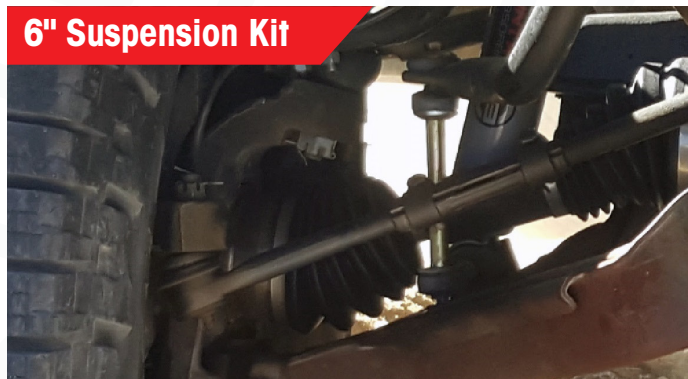
It has come to our attention that vehicles with altered (lifted) suspensions experience higher CV axle failure rates. This is because the high lift angle puts the wheel further away from the differential, increasing the operating angle, which puts more strain on the CV Axle joint.

6" Suspension Kit

1995 Chevrolet Suburban high axle angle
