Top 5 Noise Symptoms Associated With A Worn CV Shaft

TrakMotive.com

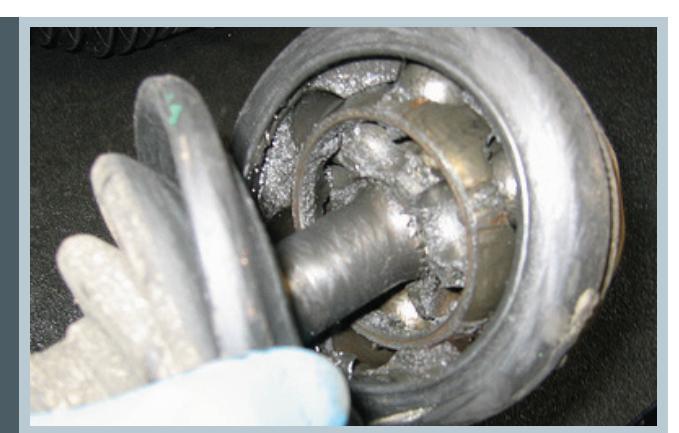
1. Popping or clicking noises when turning. This indicates a worn or damaged outer CV joint. To verify this condition, place the vehicle in reverse, crank the steering wheel to one side and drive the vehicle backward in a circle (check the rearview mirror first!). If the noise gets louder, it confirms the diagnosis and the need for a new replacement CV shaft assembly.

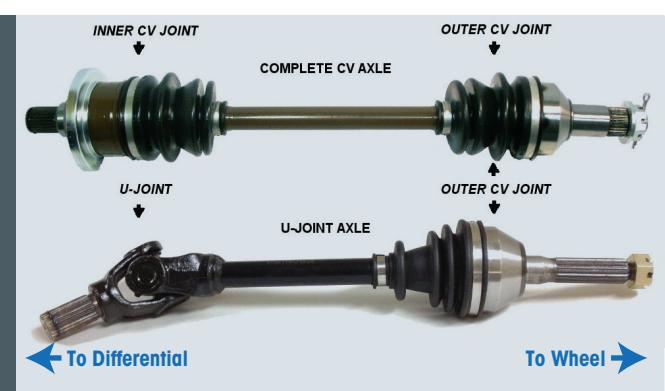
2. A "clunk" when accelerating, decelerating or when putting the transaxle into drive. The noise comes from excessive play in the inner joint on FWD applications, either inner or outer joints in a RWD independent suspension, or from the driveshaft CV joints or U-joint in a RWD or AWD powertrain. To verify the condition, back the vehicle up, alternately accelerating and decelerating while in reverse. If the clunk or shudder is more pronounced, it confirms a bad inner joint.

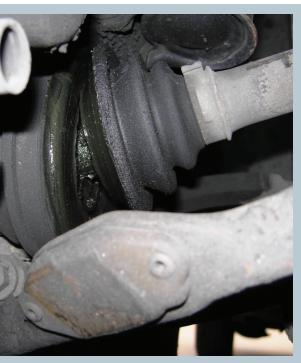
3. A humming or growling noise. This can be due to inadequate lubrication in either the inner or outer CV joint caused by a damaged or split boot. However, this symptom is more often due to worn or damaged wheel bearings, a bad intermediate shaft bearing on equal length halfshaft transaxles, or worn shaft bearings within the transaxle.

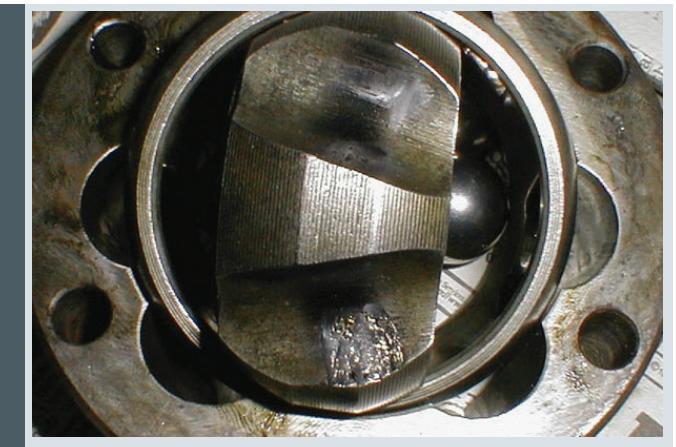
A shudder or vibration when accelerating. This may be caused by play in the inboard or outboard joints, but the most likely cause is a worn inboard plunge joint. Similar vibrations can also be caused by a bad intermediate shaft bearing on transaxles with equal length halfshafts, or by bad motor mounts on FWD vehicles with transverse-mounted engines.
