Addressing Three Common CV Axle Issues

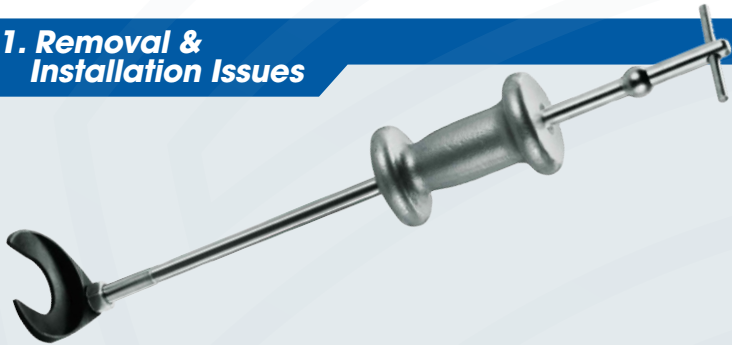
Removal

- **Problem:** Prying and striking the axle during removal often causes the circlip to become caught and damages both the axle and transmission splines.
- **Solution:** Use a CV removal tool that attaches to a slide hammer is the best method of removal to avoid damage to the splines.

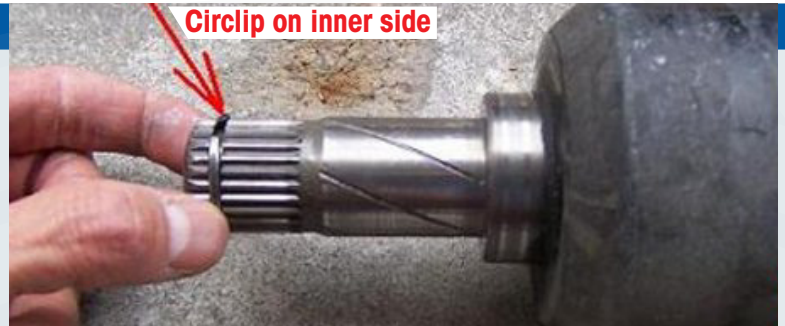
Installation

- **Problem:** The most common cause of warranty returns is improper installation. Circlips are often damaged during installation due to not being properly centered.
- **Solution:** A small amount of grease applied to the circlip will keep it centered and prevent damage during installation.

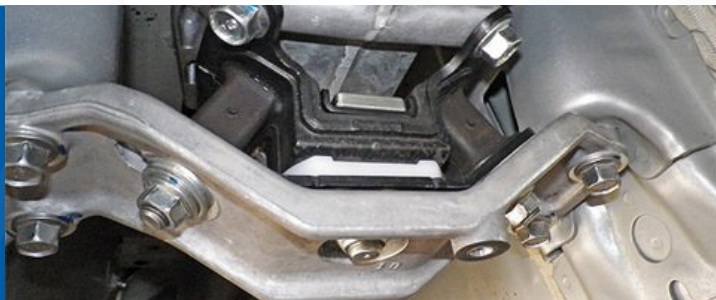
2. Addressing Subaru Vibration Issues

Problem: Subaru transmission mounts are susceptible to becoming very spongy and wear out due to the unique horizontal movement of a boxer (cylinders horizontally opposed) engine. When these mounts wear, they cause the engine/transmission to sit slightly off center.

Solution: Inspect and replace the transmission mount (if worn) to eliminate off center vibration issues. Note: If the mount is worn, the articulation angle of the new replacement axle becomes the mount that is holding the transmission in the correct location, which creates a binding vibration.

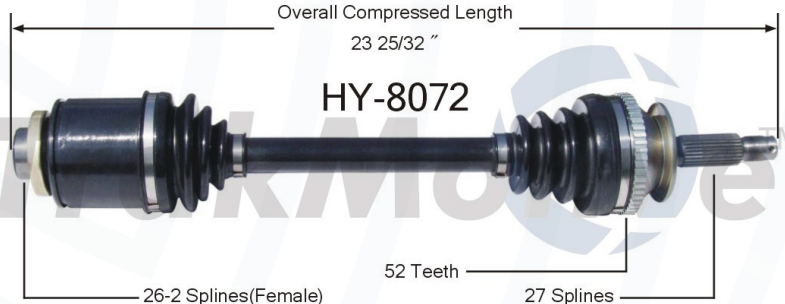
3. A Variation of 1/4" in Axle Length Can Lead to Increased Warranty Rates

Problem: Several aftermarket CV Axles suppliers accept up to 1/4" of length variation from OE for consolidation. While it may help to cover more applications with fewer sku's, it also means that the axle is not the correct length which often leads to increased warranties.

Solution: TrakMotive CV Axles are developed based on original O.E. designs; not developed from aftermarket sources. TrakMotive's only allows only a 3mm (under 1/8") length variance. This means our cv axles are much closer to OE specifications which has resulted in reduced warranty rates.
