New Intermediate Shafts

DESIGNED TO IMPROVE VEHICLE HANDLING

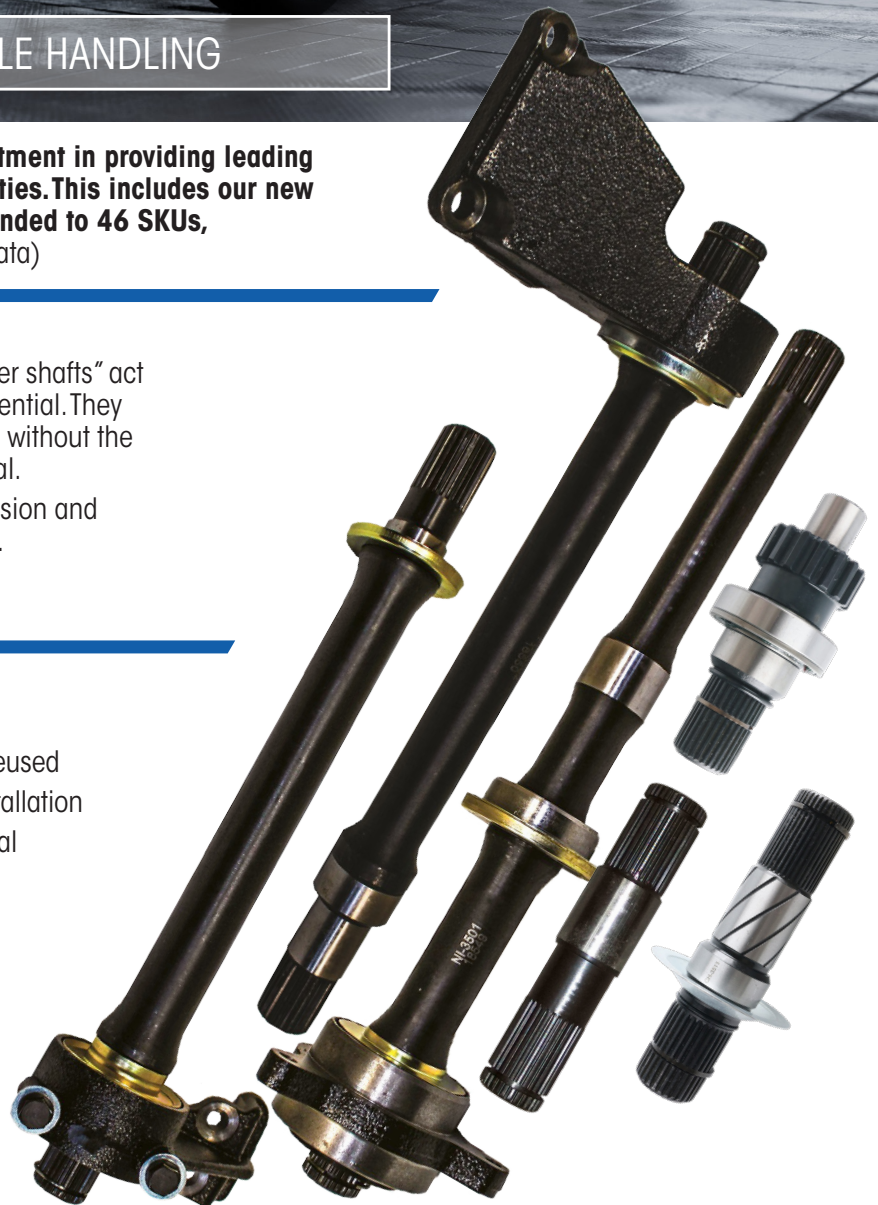
Intermediate shafts, often referred to as "stub shafts" or "inner shafts" act as the link that couples the CV axle to the transaxle or differential. They allow for the removal and installation of CV axle assemblies without the need to disturb or replace the transaxle or differential oil seal.

The intermediate shaft connects the CV axle to the transmission and ensures that the left and right CV axles are of equal lengths. The equal joint angles between the left and right CV axles reduce torque steer and improves vehicle handling.

- Intermediate shaft bearing failure
- Circlips not being replaced when intermediate shafts are reused
- Damage to splines or clips due to improper removal or installation
- Corrosion of the splines/clip due to failed dust/moisture seal

The above failures can lead to the CV axle becoming disengaged during operation causing loss of drive power and transaxle or differential damage.
