Ram Truck 1500 4WD Differential Housing Repair / Front Right, 2012-Up – Intermediate Shaft - Repair Kit CH-3511RK

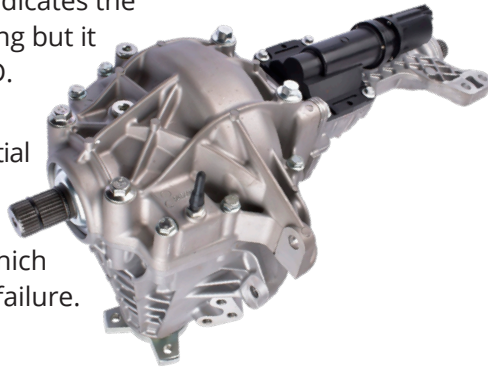
Clunking (or) vibration noises when trying to apply 4WD. The dashboard light indicates the Shift Actuator is working but it will not engage in 4WD.

The front right differential Intermediate Shaft to CV inboard joint splines are stripped which also causes a bearing failure.

TrakMotive Kit CH-3511RK (Rebuild Kit) includes all necessary parts, including a new intermediate shaft with all the components required to complete the repair, without having to spend thousands of dollars for a new differential.

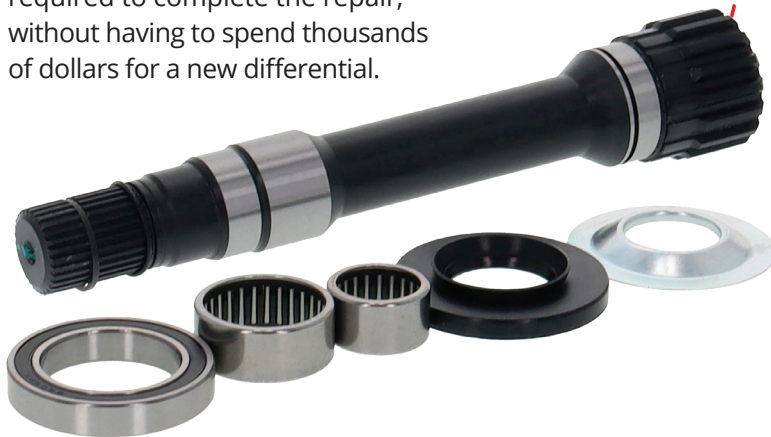
Needle Bearing Included

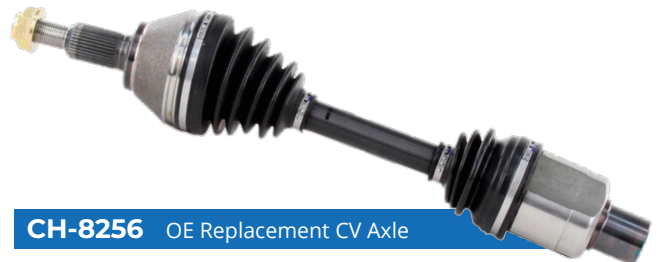
CH-8256 OE Replacement CV Axle

The original connecting CV Shaft could also be defective if the intermediate shaft is damaged and should be replaced.

We strongly recommend replacing the CV Shaft with a new TrakMotive CH-8256, CH-8256HDX or CH-8256XTT when completing the job.

Note: If “upgrading” to the CH-8256HDX (or) CH-8256XTT, the CV Axles should be installed in pairs (left & right) to ensure proper performance.
